WRDC-TR-89-4055

COMPENDIUM OF FRACTOGRAPHIC DATA FOR COMPOSITE  
MATERIALS

INTERIM REPORT  
Covering 9-22-86 through 10-31-88

C. Hua  
M. Yamashita  
Boeing Advanced Systems  
P.O. Box 3707  
Seattle, WA 98124

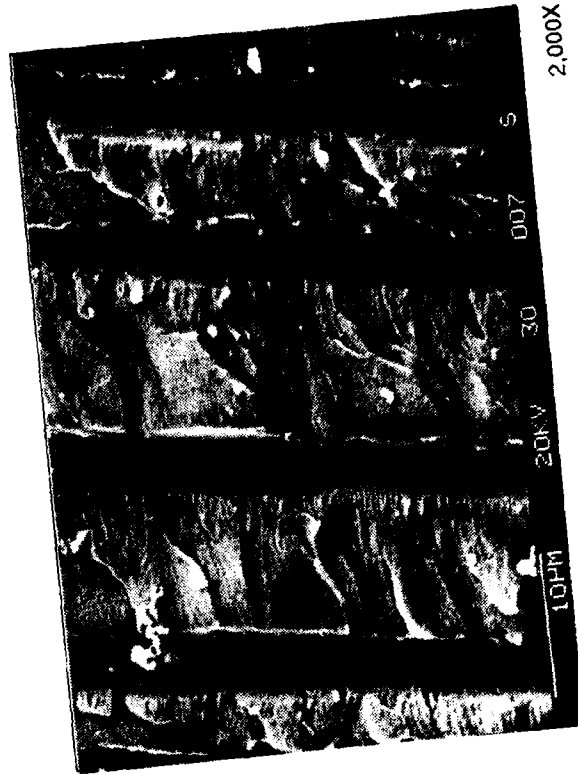
Figure 3.4-2. SEM Fractographs of Interlaminar Mode I Tension, Room Temperature, 0/90 Fracture in AS-4/3501-6

**Interlaminar Mode I Tension.** Optical examination revealed a smooth, reflective surface. SEM fractography revealed rivermarks and resin microflow in the matrix rich areas between plies indicating propagation in a direction consistent with the mechanically induced crack direction (Fig. 3.4-2). Fiber/matrix adhesion was good.

Legend:  
F fiber/matrix separation  
R rivermarks  
Mechanically induced crack direction

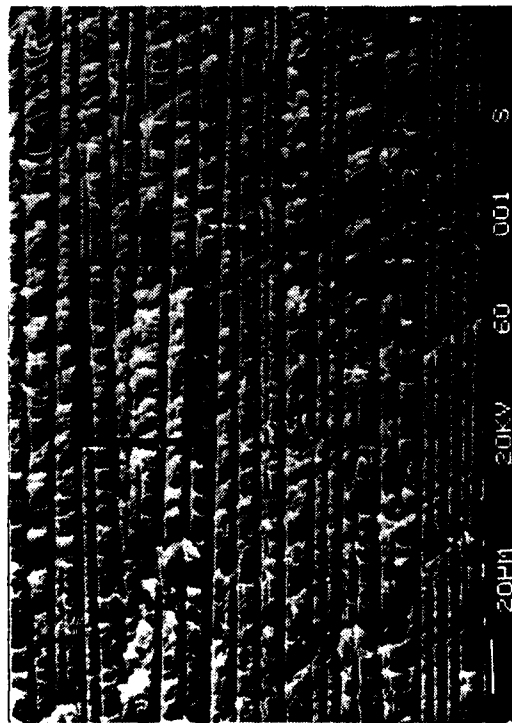
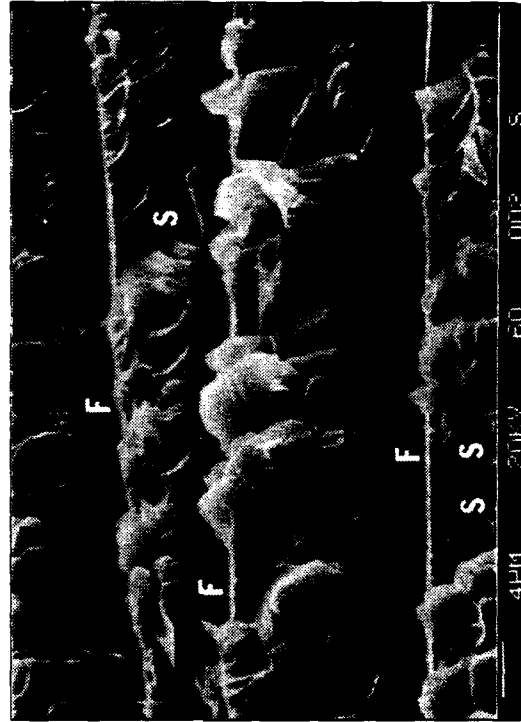
Figure 3.4-3. SEM Fractographs of Interlaminar Mode II Shear, Room Temperature, 0/90 Fracture in AS-4/3501-6

**Interlaminar Mode II Shear.** Visual examination of the Mode II shear surface showed a milky white appearance when the specimen was held at an angle to the light. SEM examination revealed hackles and scallops, indicative of a Mode II shear failure (Fig. 3.4-3). As in the Boeing analysis, the propagation direction could not be determined from these features. The fiber/matrix adhesion was good.

- F fiber/matrix separation
- H hackle
- S scallop

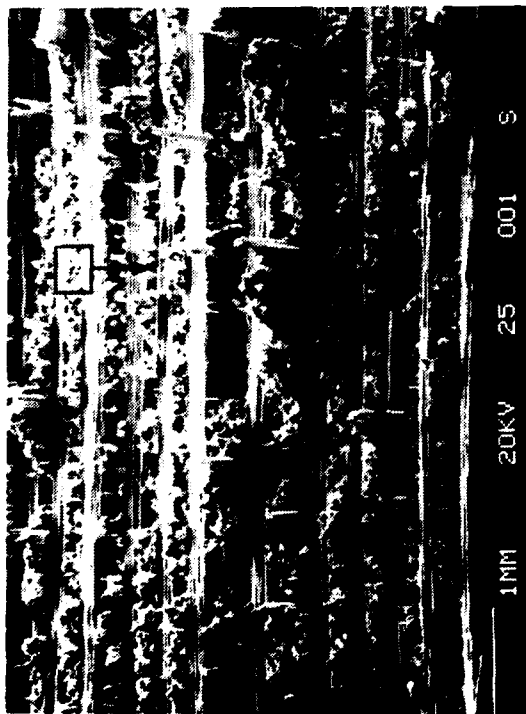
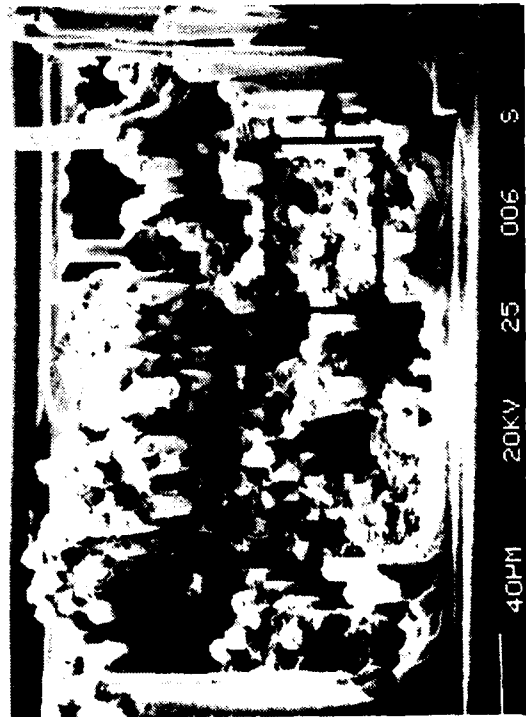
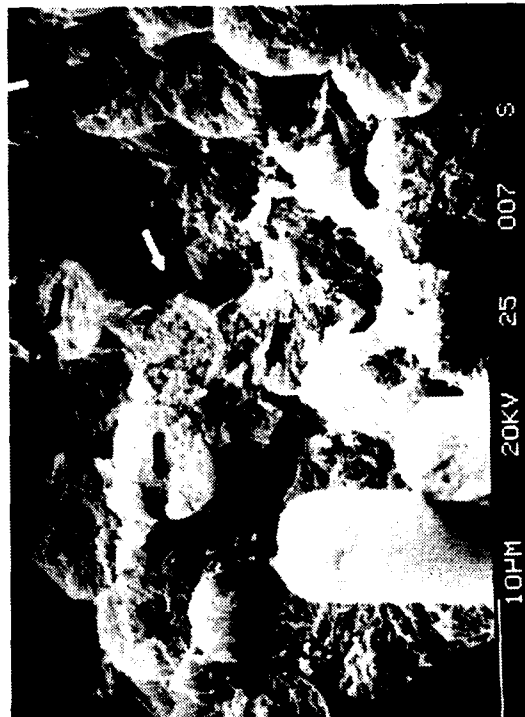
Figure 3.4-4. SEM Fractographs of Translaminar Tension, Room Temperature Fracture in AS-4/3501-6

**Translaminar Tension.** Macroscopically, the fractures were flat and planar. At higher magnifications the edges appeared rough with segregated fiber bundles protruding from the fracture plane. Fiber pullout was observed in varying proportions over the entire fracture. SEM fractography revealed fiber end fractures with fan patterns indicating the propagation through each fiber (Fig. 3.4-4). Fiber end fractures often initiated tangentially to the previous failed fiber and propagated off-axis. The overall propagation direction indicated by the fiber end fractures was consistent with the mechanically induced crack direction.

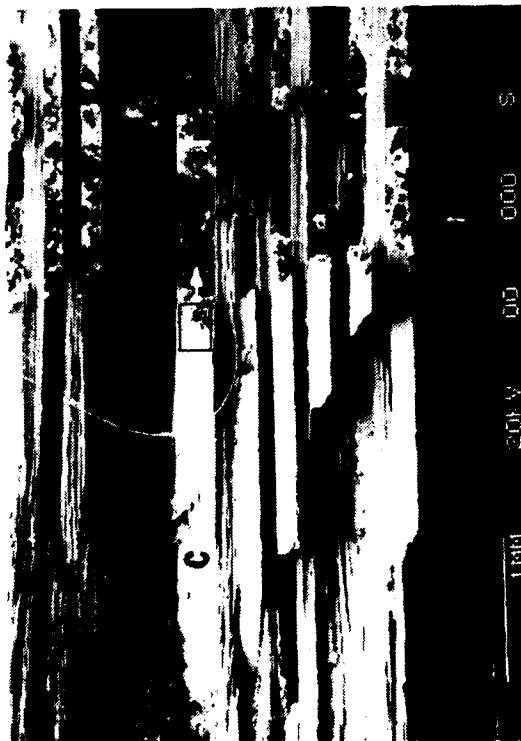
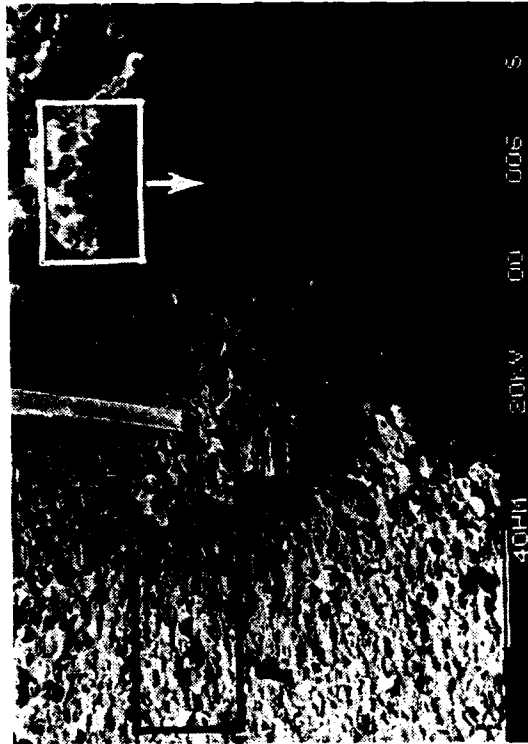
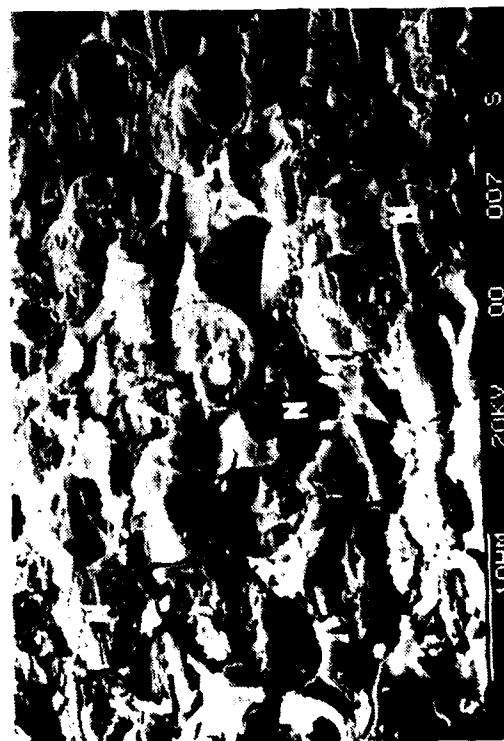
Figure 3.4-5. SEM Fractographs of Translaminar Compression, Room Temperature Fracture in AS-4/3501-6

**Translaminar Compression.** Macroscopically, the fractures were jagged. At higher magnifications, the compressive region was locally flat with all fibers and the matrix fracture in the same plane. The fracture was littered with debris. Fiber buckling was observed in both the 0 and 90 degree plies. SEM fractography of the compressive region revealed fiber end fractures, each exhibiting a compressive zone and a tensile zone divided by a neutral axis (Fig. 3.4-5).

- C compression zone
- T tension zone
- N neutral axis

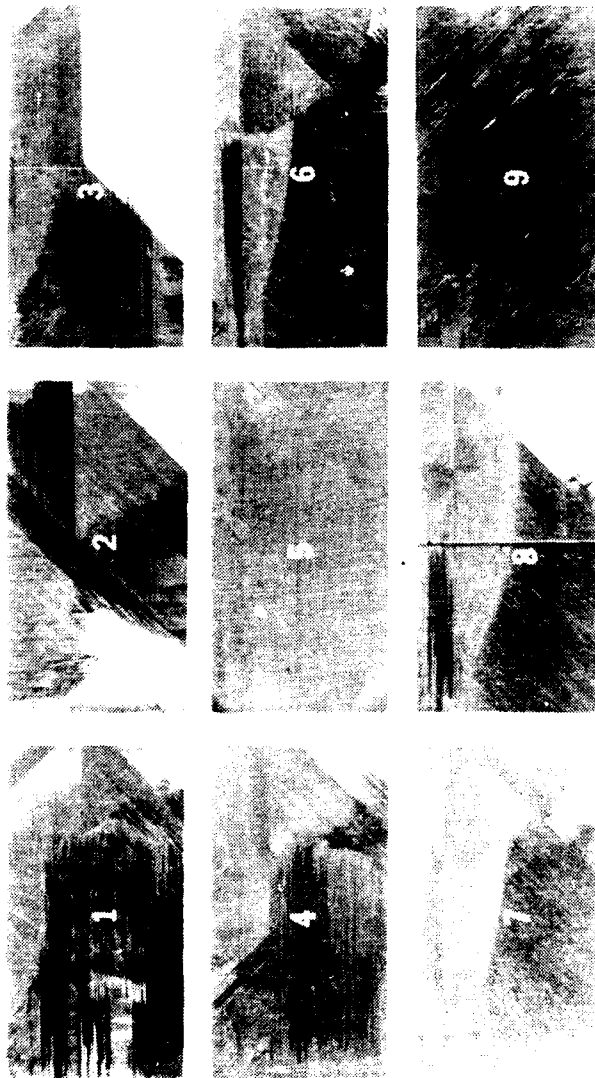
**Cryogenic Deply.** The last quarter was used for cryogenic deply and prepared by soaking in liquid nitrogen prior to peeling the layers with tweezers. Only the existing delaminations were peeled apart. Examination of these layers revealed light colored, less reflective regions similar to those observed in the thermal oxidative deply (Fig. 3.4-16). These regions correspond to the expected delamination locations. Fractography was not performed on these regions.

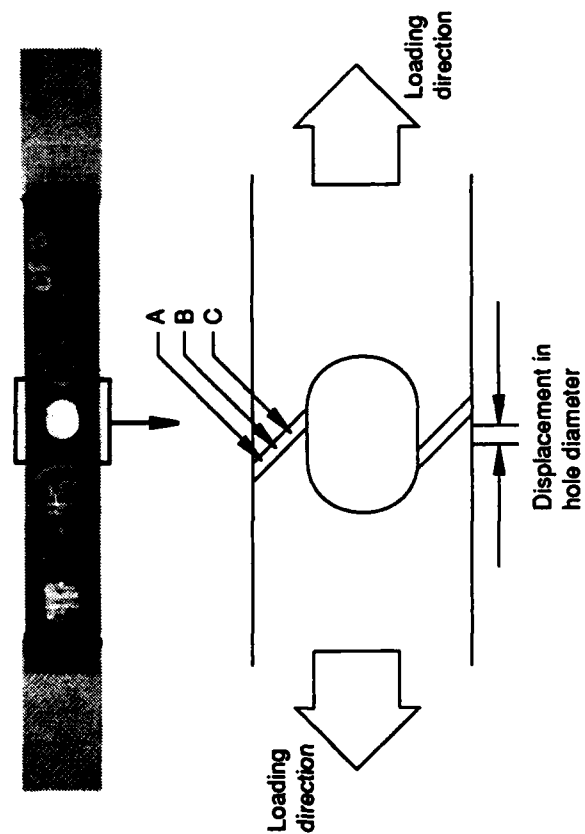
Figure 4.4-13. Open Hole Tension Specimen (Large  $K_t$ ) with Locations of Optical Photomicrographs

In the large  $K_t$ ,  $\pm 45$  degree layup specimen, visual observation revealed an elongated hole in the loading direction. This hole was caused by loading the  $\pm 45$  degree ply layup in 0 degree tension. The specimen did not produce a translaminal fracture as it would have with a 0/90 degree ply layup. Rather, there were two fractures, originating from the sharp radius of the hole and propagating in opposite directions to one another. Three locations were examined to determine the fracture modes and origins (Fig. 4.4-13). Removing the delaminated surface ply revealed rivermarks in two locations indicating the crack propagated toward the outer edge of the specimen. The cracks initiated near a third location, under Mode II shear (Fig. 4.4-14).

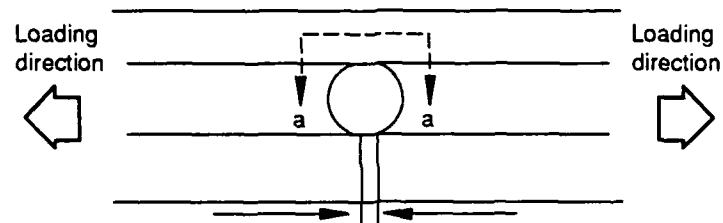
Figure 4.4-15. Open Hole Tension Fracture; 0 Degree Layup, Large  $K_I$

In the large  $K_t$ , 0 degree layup specimen, two main fractures occurred in the intralaminar region. They originated at opposite edges of the hole and propagated outward and parallel to one another (Fig. 4.4-15a). One crack was examined optically; it had occurred under Mode II shear (Fig. 4.4-15b).

(b) Optical photomicrograph of fracture surface, location a-a; magnified 400X

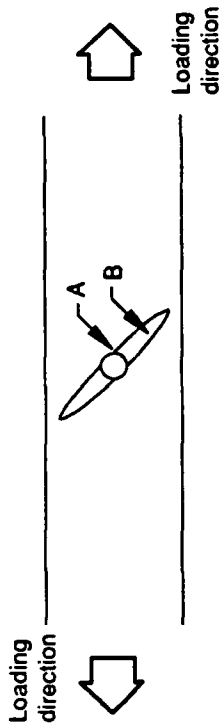
Figure 4.4-16. Open Hole Tension Fracture;  $\pm 45$  Degree Layout, Small  $K_I$

The fracture of the small  $K_t$ ,  $\pm 45$  degree layup specimen produced delamination approximately 0.5 inch to both sides of the open hole (Fig. 4.4-16a). The microscopic examination of the delamination revealed that the fracture was created predominately in almost pure Mode II shear (Fig. 4.4-16b). However, a Mode I tension fracture occurred near the outermost region of the delamination (Fig. 4.4-16c).

(b) Optical photomicrograph of location A, near the hole edge; magnified 400X

(c) Optical photomicrograph of location B, at the center of delamination; magnified 400X

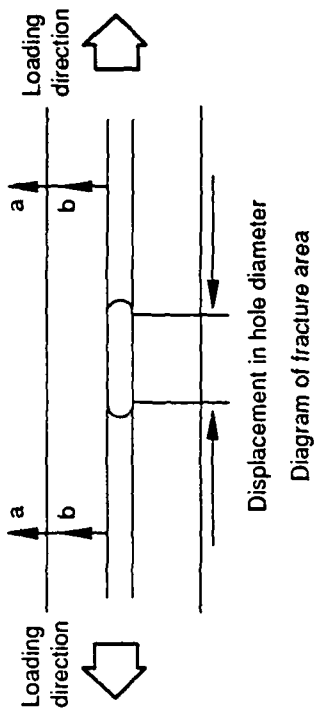
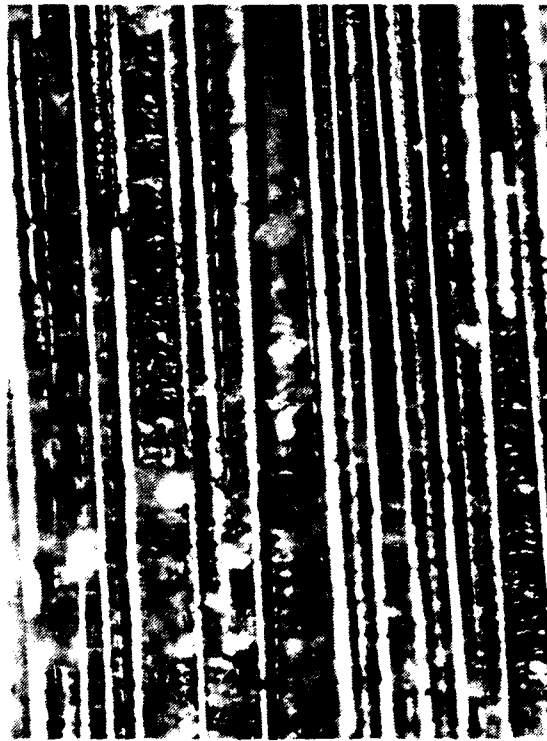
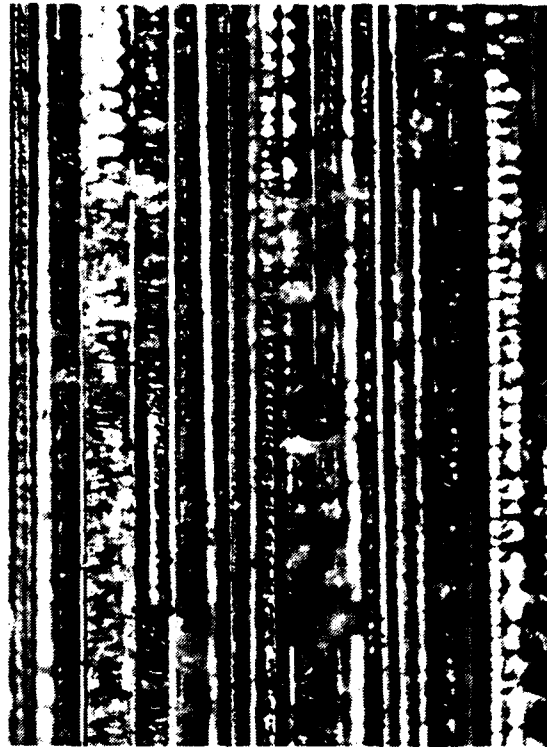
Figure 4.4-17. Open Hole Tension Fracture; 0 Degree Layup, Small  $K_t$

In the small  $K_t$ , 0 degree layup, the fractures occurred in the intralaminar region. Fractography was performed on two fracture surfaces: one near to the hole and the other toward the outer edge (Fig. 4.4-17a). It was revealed in the optical examination that the fractures occurred by pure Mode II shear, as evidenced by the presence of hackle formations (Figs. 4.4-17b and c). In contrast to the small  $K_t$ ,  $\pm 45$  degree layup specimen, the hole was enlarged by at least five-times.

(b) Optical photomicrograph of fracture surface, location a-a; magnified 400X

(c) Optical photomicrograph of fracture surface, location b-b; magnified 400X

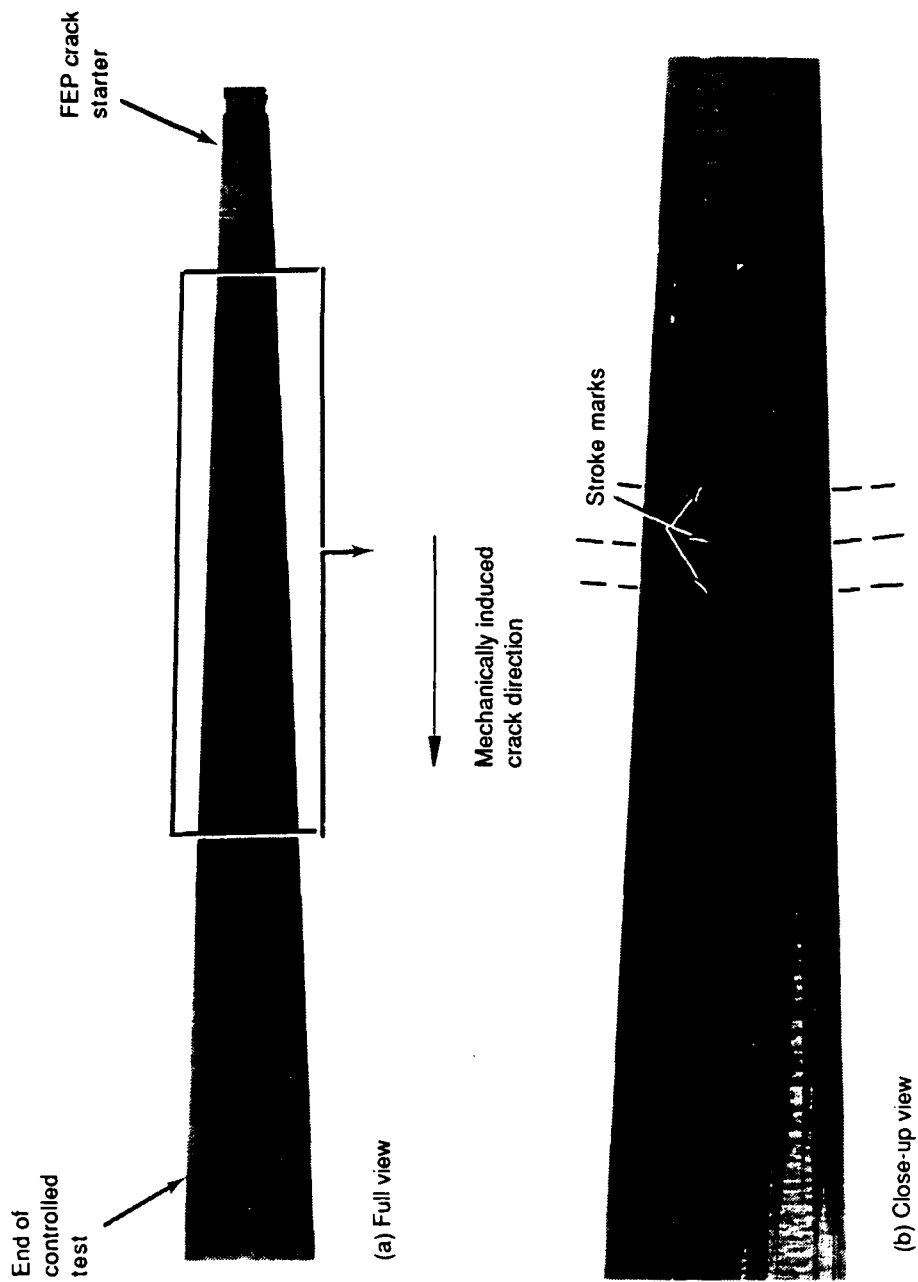
Figure 4.4-18. Photomacrographs of Interlaminar Mode I Tension, RT/Dry Creep Fracture

Interlaminar Mode I Tension, RT/Dry. Visual observation revealed a smooth, glassy surface typical of an interlaminar Mode I tension fracture. There were visible crack arrest marks ("beach marks") running perpendicular to the mechanically induced crack direction (Fig. 4.4-18). The spacing between these marks was quite consistent due to the constant loading rate throughout the creep test. Optical fractography focused on what appeared to be a stripped fracture region. Due to the re-initiation of the crack, the location just after crack arrest appeared much rougher than the region just prior to it (Fig. 4.4-19). The rivermarks were more readily observed in the region prior to the crack arrest.

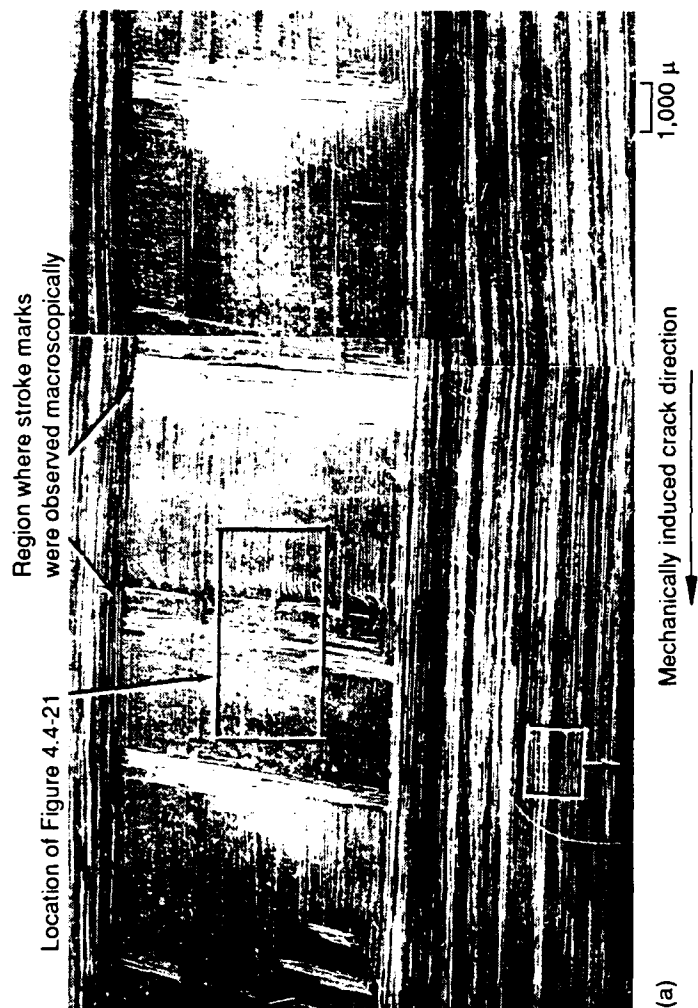
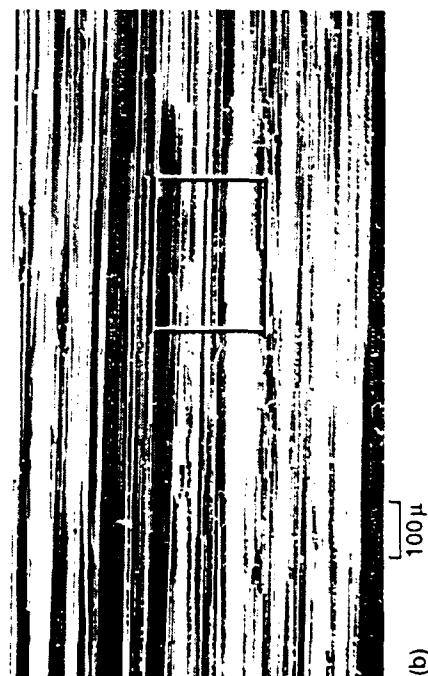
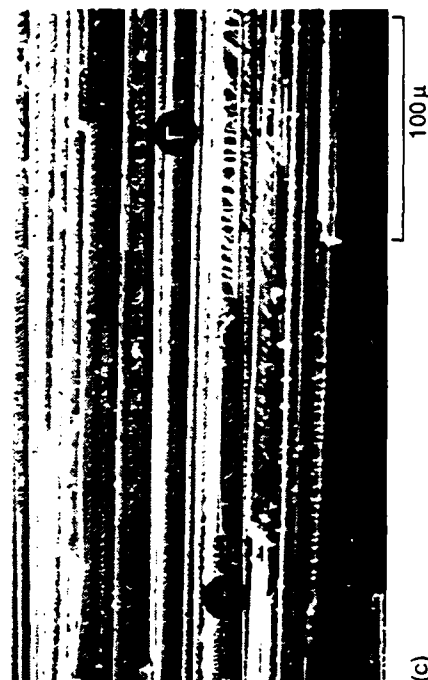
Figure 4.4-20. SEM Fractographs of Interlaminar Mode I Tension, RT/Dry Creep Fracture

SEM fractographs were taken of the three regions of fracture, including the location of the crack arrest (Fig. 4.4-20). The fracture topography was smooth with distinct rivermarks just prior to the periodic crack arrest; after reinitiation of the crack, the fracture appeared uneven with very fine rivermarks (Fig. 4.4-21).

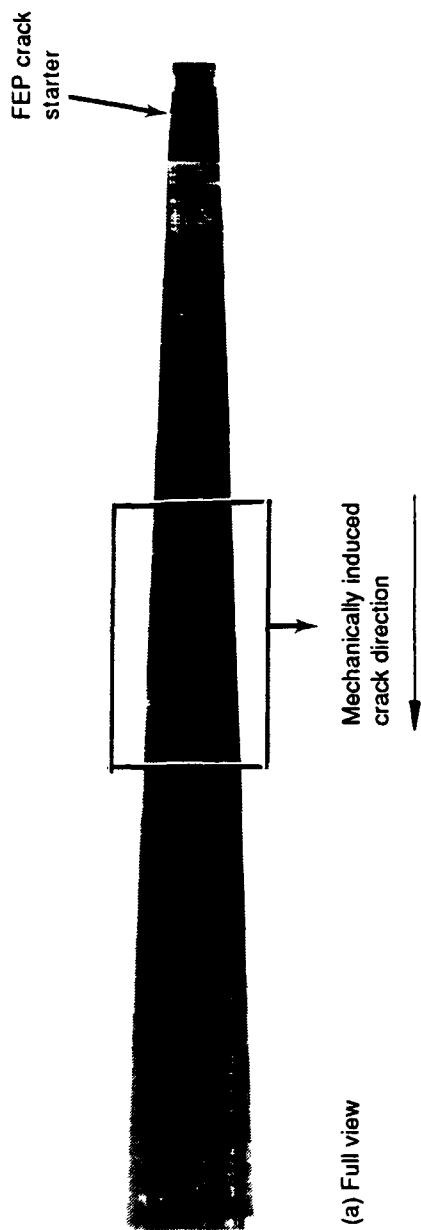
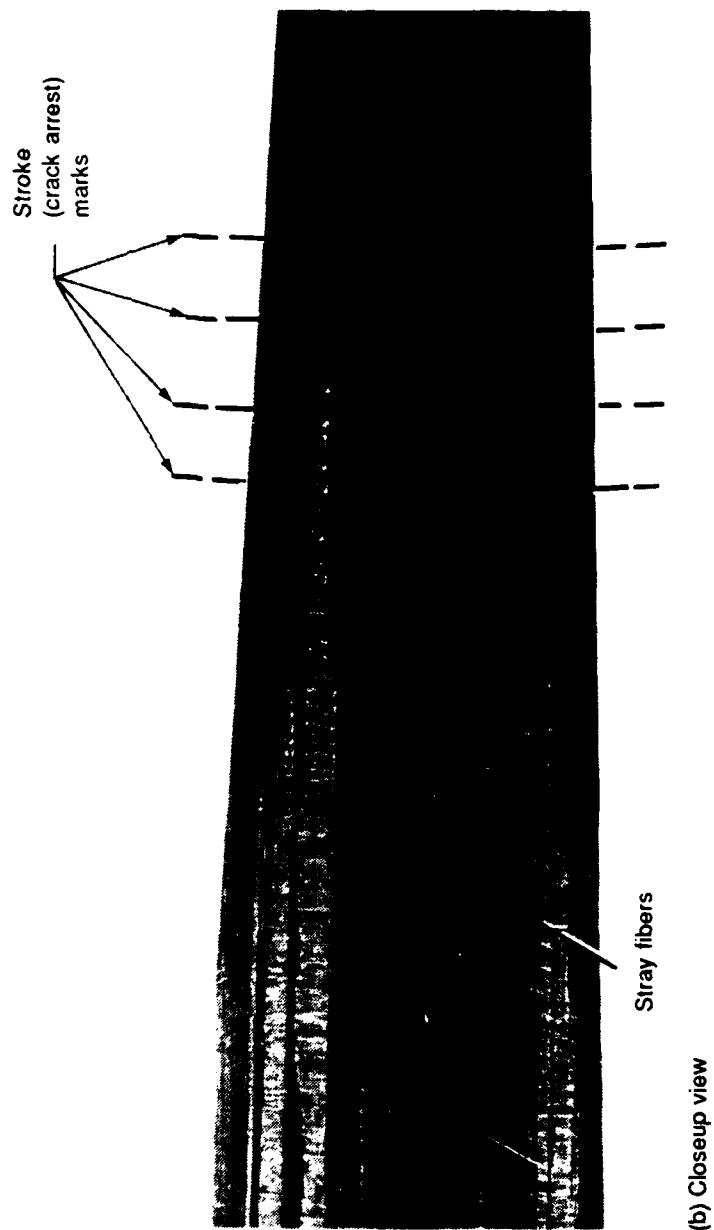
Figure 4.4-22. Photomicrographs of Interlaminar Mode I Tension, 270 F/Dry Creep Fracture

Interlaminar Mode I Tension, 270°F/Dry. Visual observation revealed a smooth, glassy fracture surface similar to that of the RT specimen. Crack arrest marks were again observed (Fig. 4.4-22). However, there were fragments of loose fibers on the fracture surface. These fibers may have separated from the resin matrix prematurely due to poor adhesion. The fracture topography at the region before and after the crack arrest was smooth (Fig. 4.4-23), unlike that of the fracture created at RT. The difference between the RT and 270°F fractures may be due to lower resistance to crack propagation in the 270°F specimen. The SEM analysis confirmed the observations made during the optical analysis (Fig. 4.4-24).

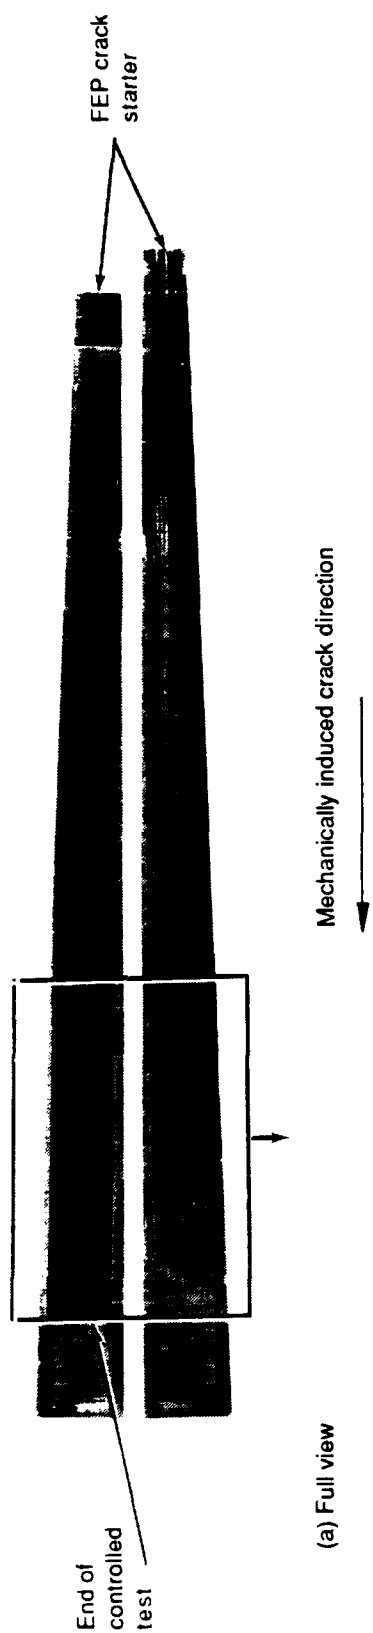
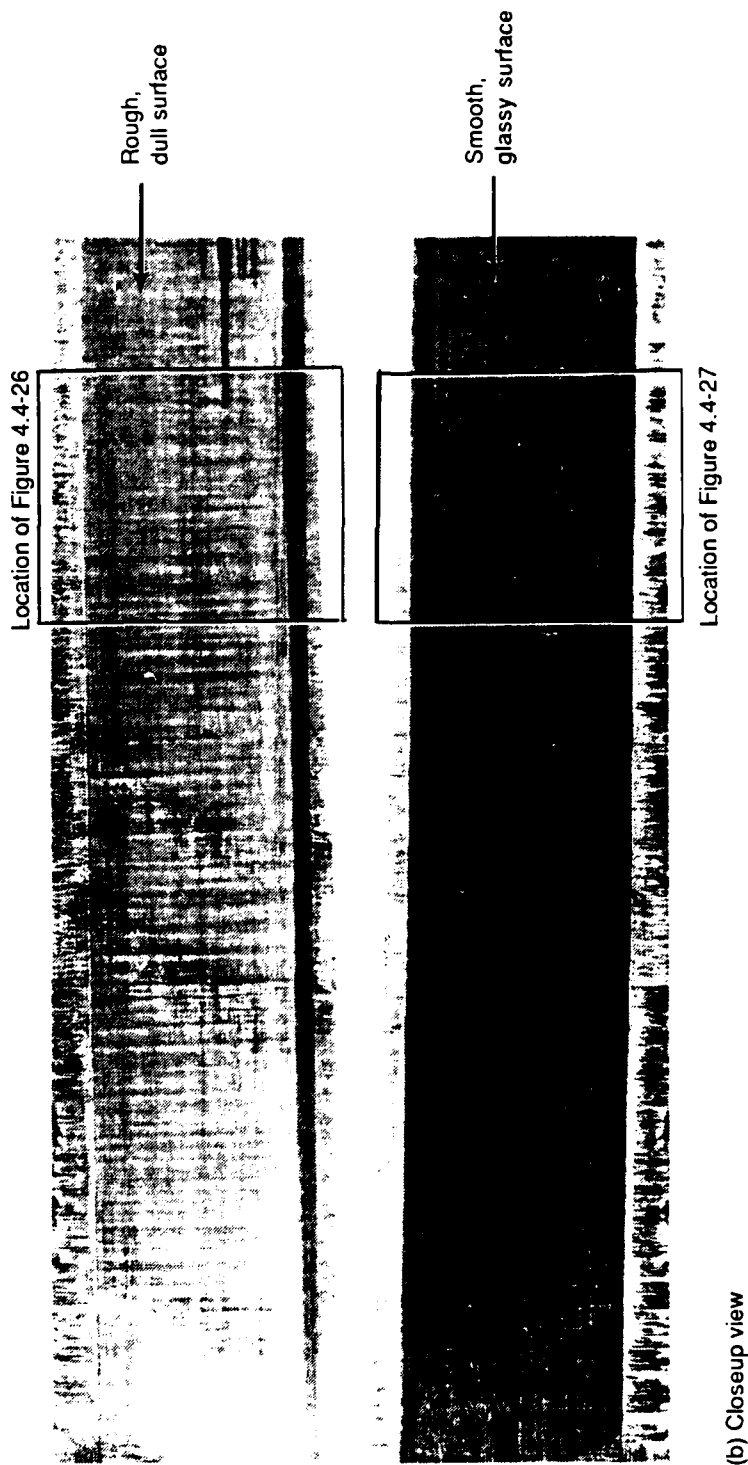
Figure 4.4-25. Photomicrographs of Interlaminar Mode II Shear, RT/Dry Creep Fracture

Interlaminar Mode II Shear, RT/Dry. Visually, the mating fracture surfaces looked somewhat different: one surface smooth and glassy, the other rough and dull (Fig. 4.4-25). Crack arrest marks were observed on the fracture surfaces at the ends of the specimen and at the center. SEM fractographs revealed that the glassy surface consisted largely of scallops (with some hackles) (Fig. 4.4-26) and the rough surface exhibited mainly hackles (with some scallops) (Fig. 4.4-27).

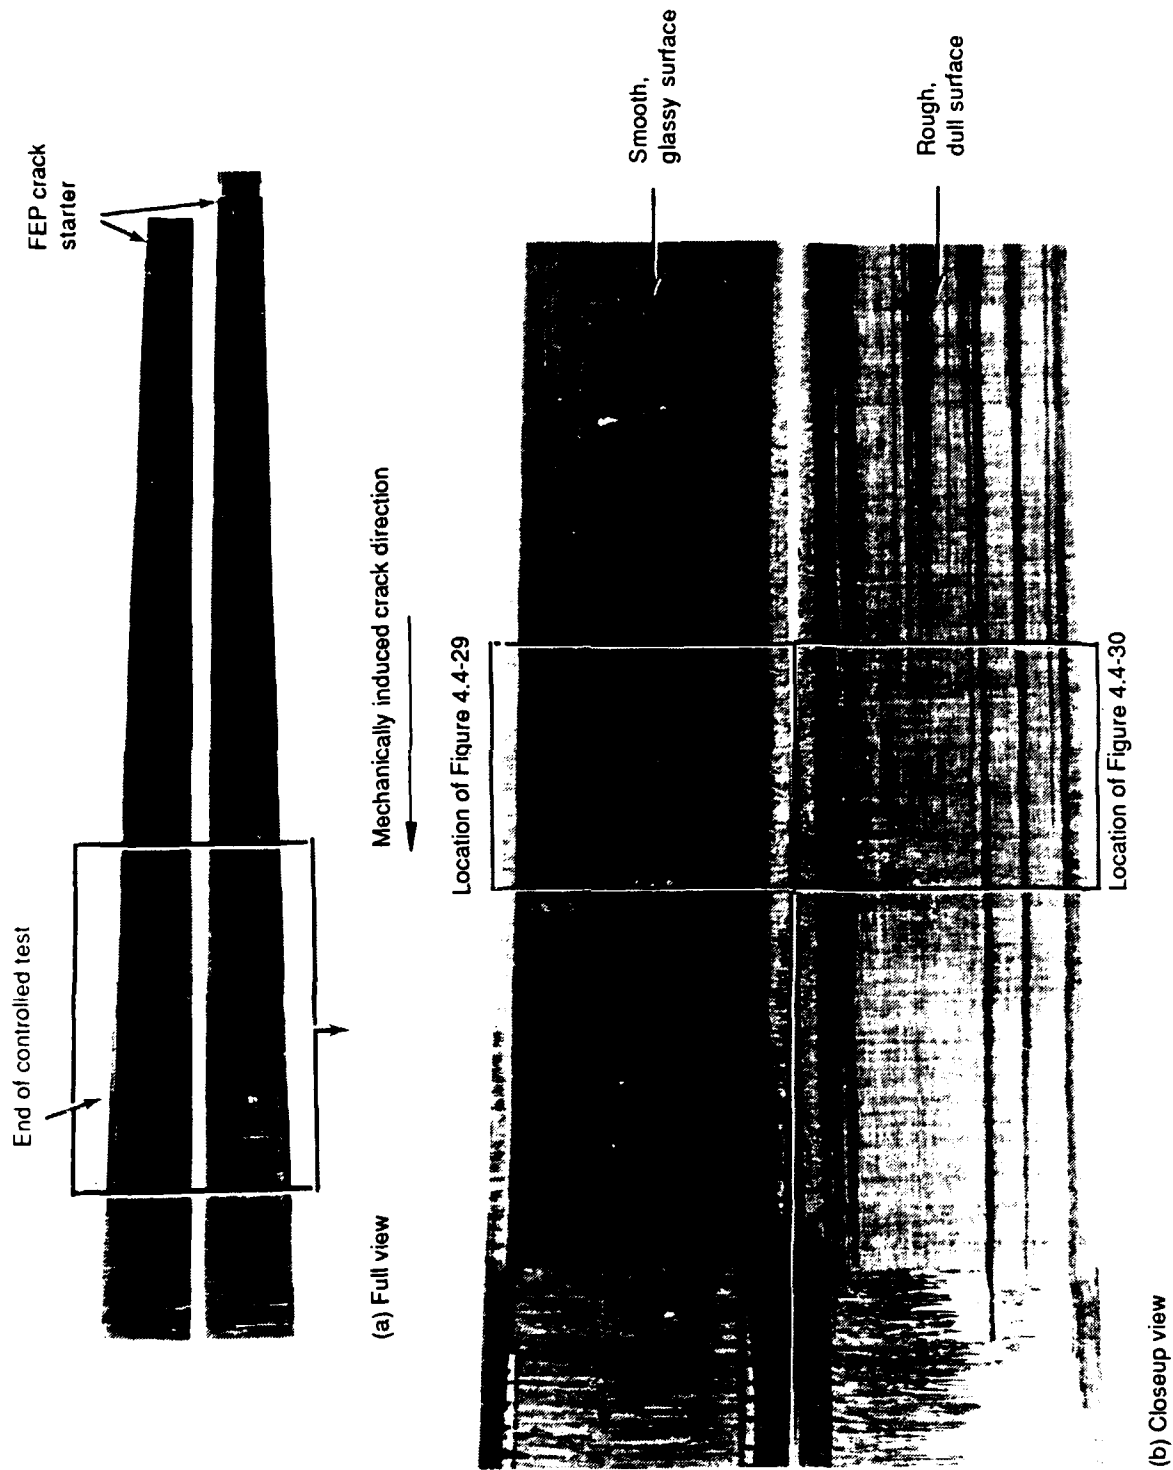
Figure 4.4-28. Photomacrographs of Interlaminar Mode II Shear, 270 F/Dry Creep Fracture

Interlaminar Mode II Shear, 270°F. Visual examination revealed a fracture with smooth and glassy surface on one of the mating sides and rough and dull on the other (Fig. 4.4-28). This was similar to the fracture surfaces created at room temperature. The glassy surface exhibited mostly of scallops (with some hackles) (Fig. 4.4-29), and the

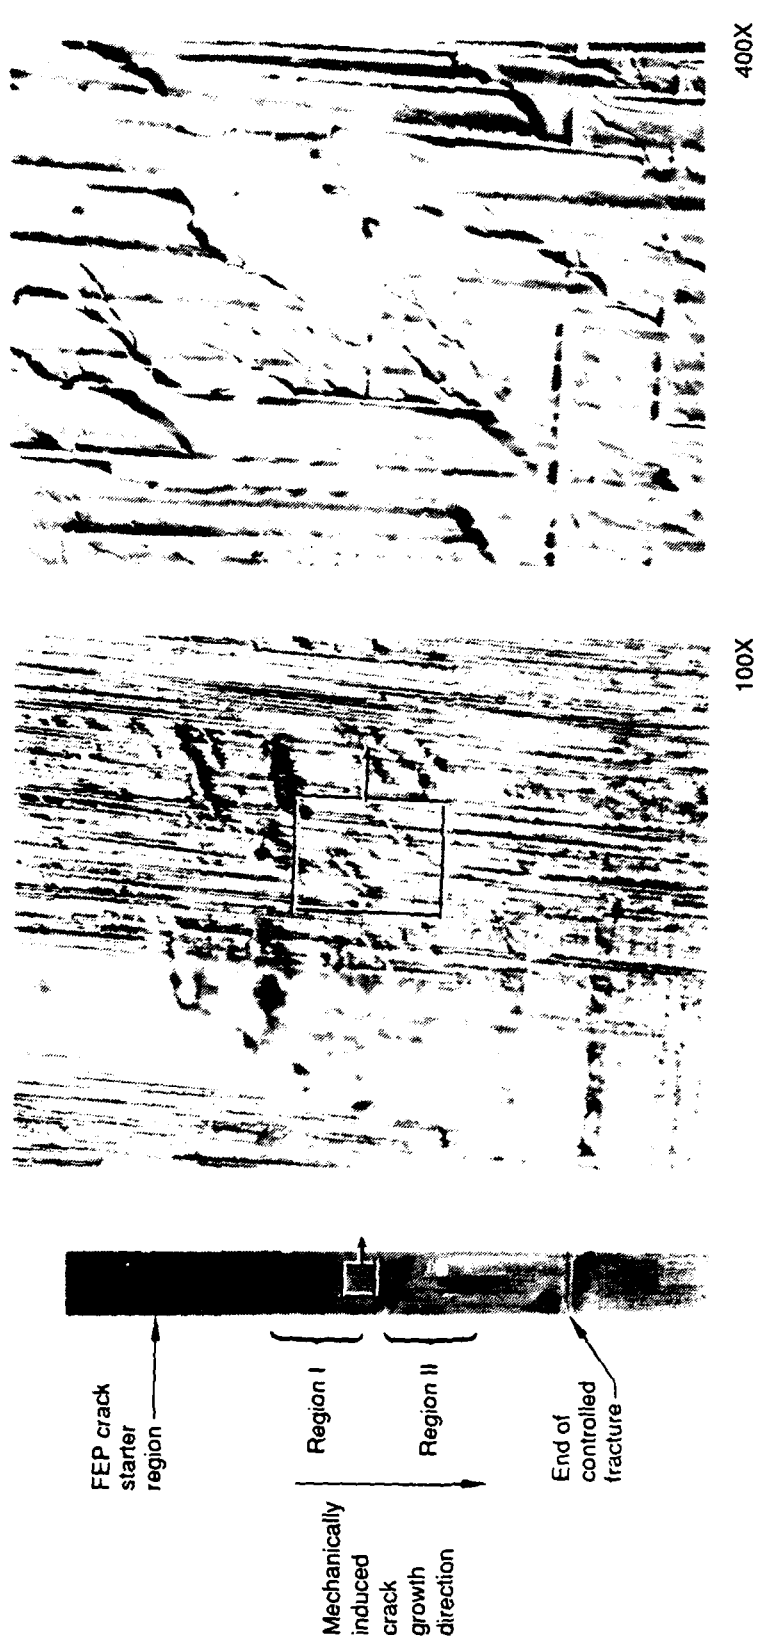
Figure 4.4-31. Optical Photomicrographs of Interlaminar Mode I Tension, High Rate, Room Temperature Fracture Between the 0/90 Plies

Under the optical microscope, a cleavage fracture was observed with numerous rivermarks showing an overall crack direction (Fig. 4.4-31).

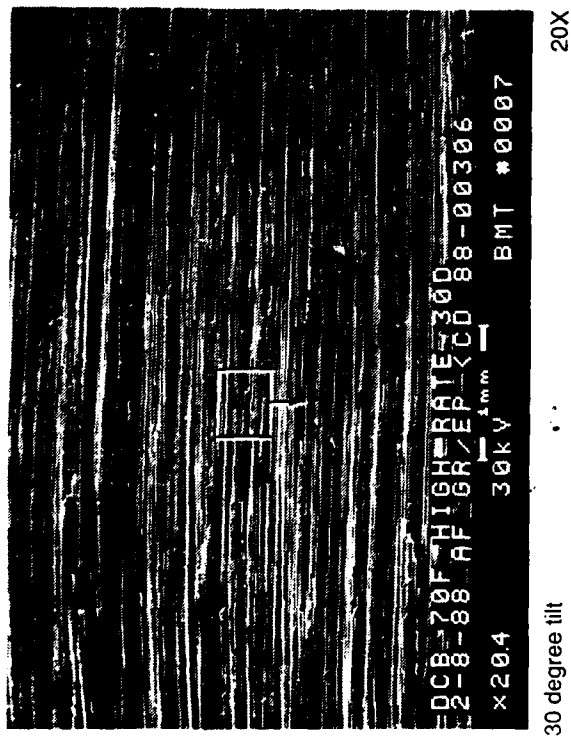
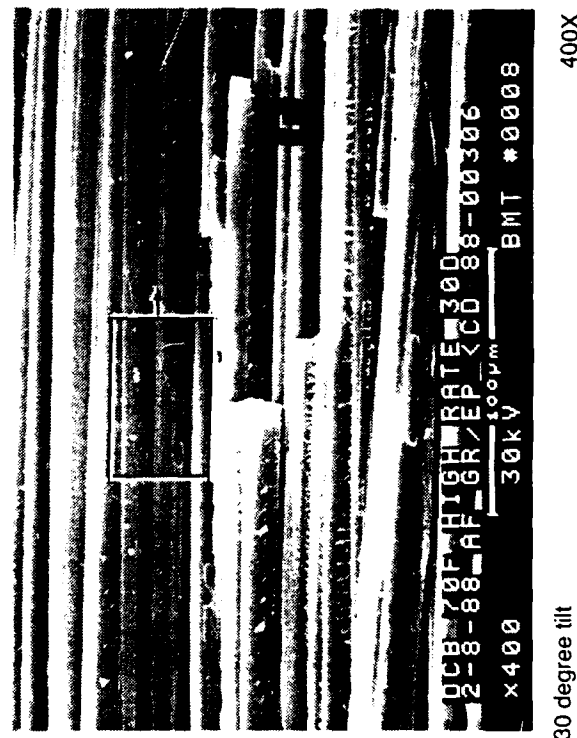
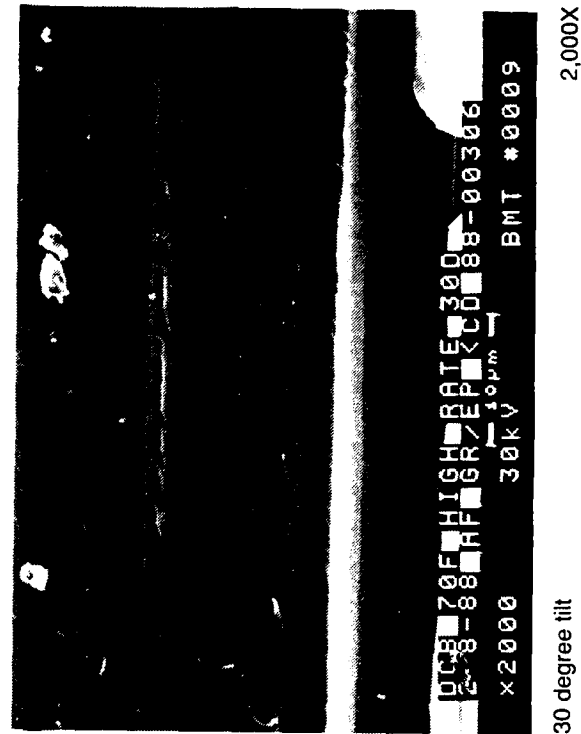
Figure 4.4-32. SEM Fractographs of Interlaminar Mode I Tension, High Rate, Room Temperature Fracture (Region I)

SEM analysis showed that Region I experienced a lower energy fracture than Region II, as evidenced by its rougher surface and more mixed mode fracture (Fig. 4.4-32). This may be a result of the initially delaminated portion driving the crack at a higher rate. There were also many fiber splinters in Region II (Fig. 4.4-33).

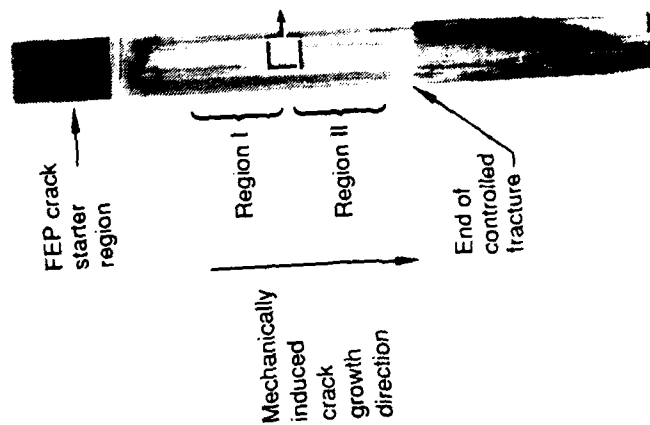
Figure 4.4-34. Optical Photomicrographs of Interlaminar Mode II Shear, High Rate, Room Temperature Fracture Between the 0/90 Plies

Optical microscopy of the fracture surface showed a difference between the high rate specimen and the typical ENF specimen tested at constant rate (Fig. 4.4-34). Due to the very rapid fracture, hackles were formed in various tilts and shapes; at slower crack growth rates, the hackles tend to form parallel to one another. As noted previously on Mode I specimens, regions created by initial and secondary projectile penetration (resulting in different crack growth rates) exhibited no distinctly different features (Fig. 4.4-35 and 4.4-36).

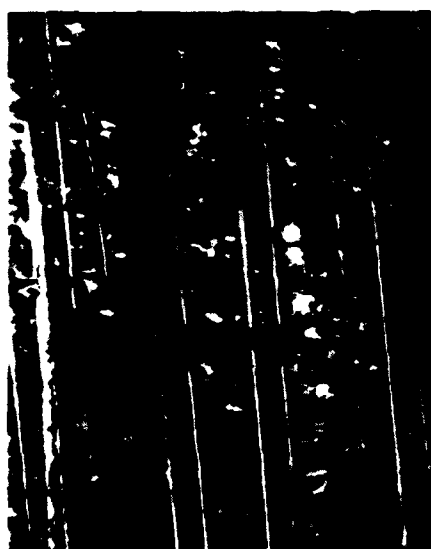
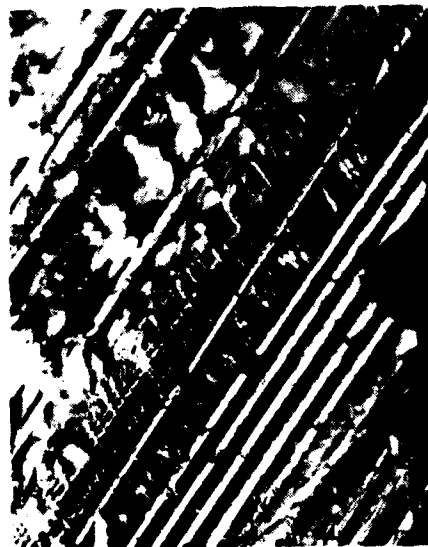
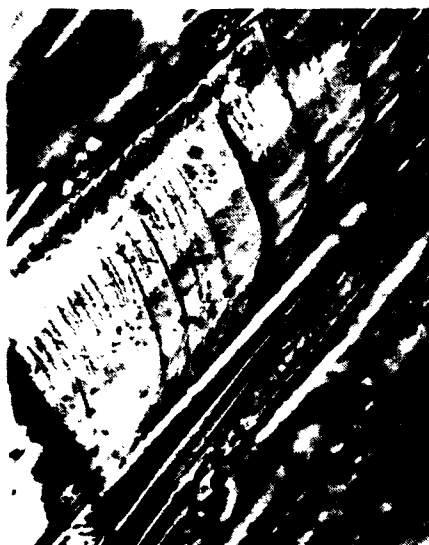
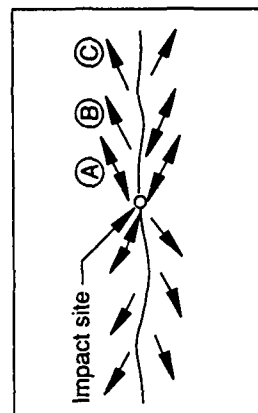
Figure 4.4-38. Optical Photomicrographs of Interlaminar Fracture of Compression-After-Impact, RT/Dry Specimen (AS-4/3501-6)

delamination which was exposed for further examination to determine the mode of failure in the vicinity of the impacted area. An examination was conducted under the optical microscope. In the region immediately surrounding the impact site (0.3 inch in diameter), the features were predominately hackle formations indicating Mode II shear failure. The outer perimeter of the impact site was predominately covered with rivermarks and resin microflow indicating Mode I tension failure mode (Fig. 4.4-38). The crack initiated at the impact site and propagated radially through the specimen from the tool side in both interlaminar and translaminar fracture modes (Fig. 4.4-39).

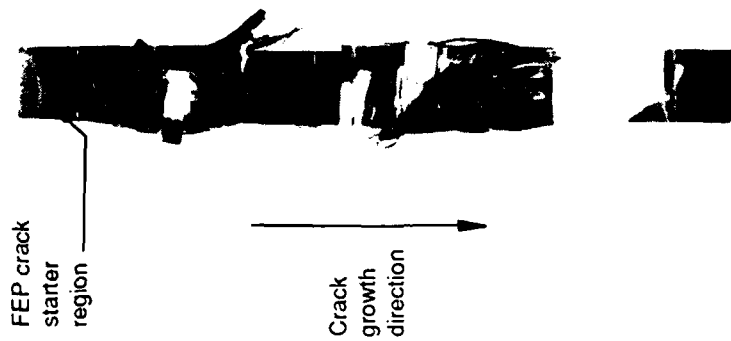
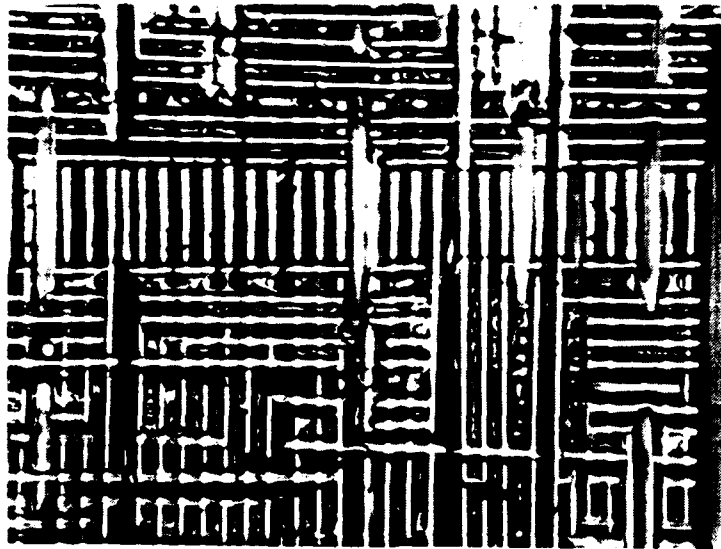
Figure 4.4-40. Optical Photomicrographs of Interlaminar Mode I Tension, Elevated Temperature, 0/90 Fracture

Optical examination showed that the fibers had just enough resin to hold them together. Due to the minimal resin content, there were no signs of rivermarks or resin microflow to indicate crack propagation direction (Fig. 4.4-40).

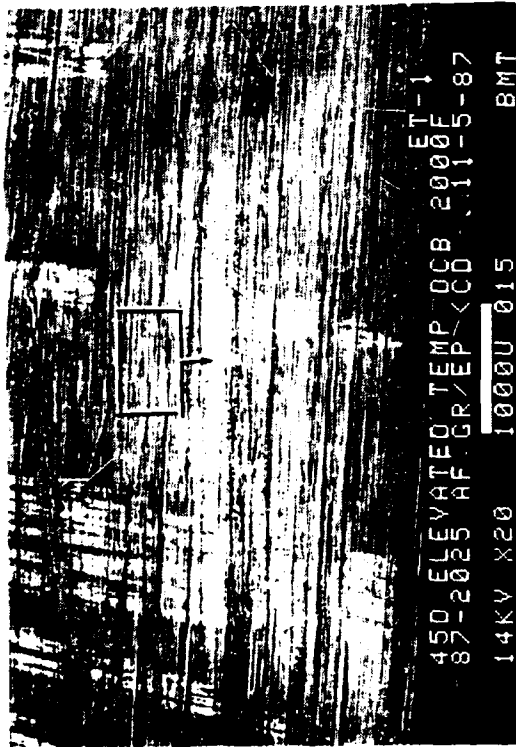
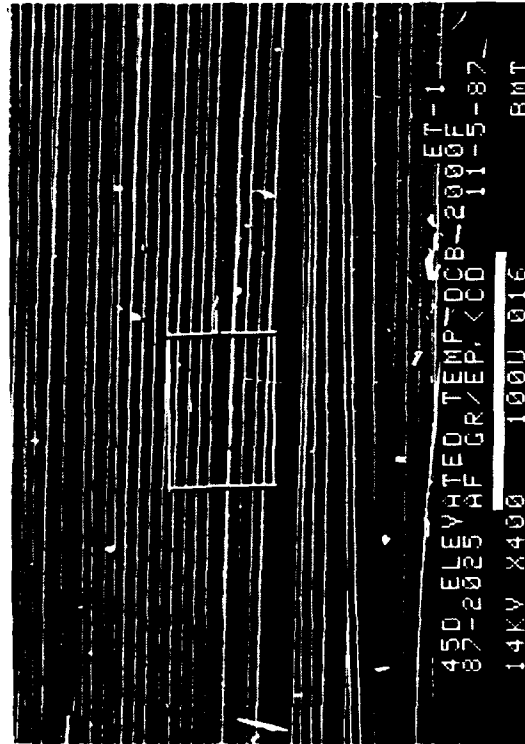
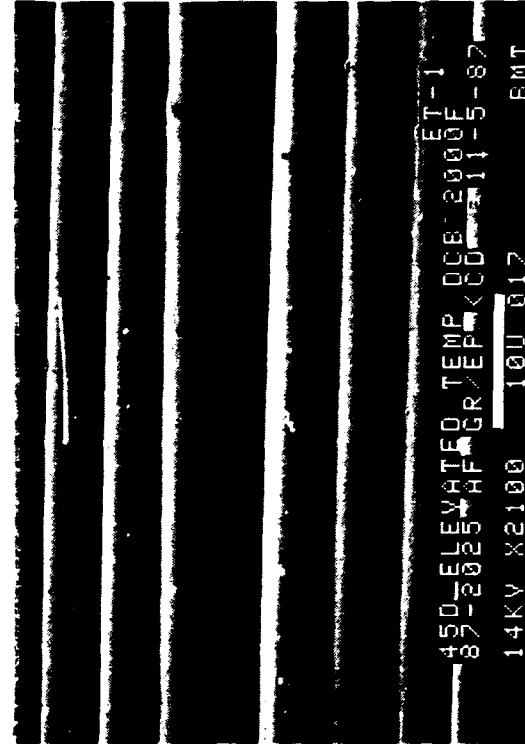
Figure 4.4-41. SEM Fractographs of Interlaminar Mode I Tension, Elevated Temperature, 0/90 Fracture

**Interlaminar Mode I Tension.** Visual observation revealed feather-like, resin-starved carbon fibers on the outermost ply, which was the first exposed to the flame. The remaining 23 plies delaminated, but were kept intact by residual resin. The fracture surface created prior to exposure to the elevated temperature, appeared quite low in resin content, as evidenced by the unfilled regions between the fibers, and exhibited the smooth, glassy surface typical of Mode I tension fractures.
